Report: 10284 Black Mountain Rd #199, San Diego, CA 92126 Address:

ACE HOME INSPECTION

May 09, 2013

Inspected By: Donald L. Walker

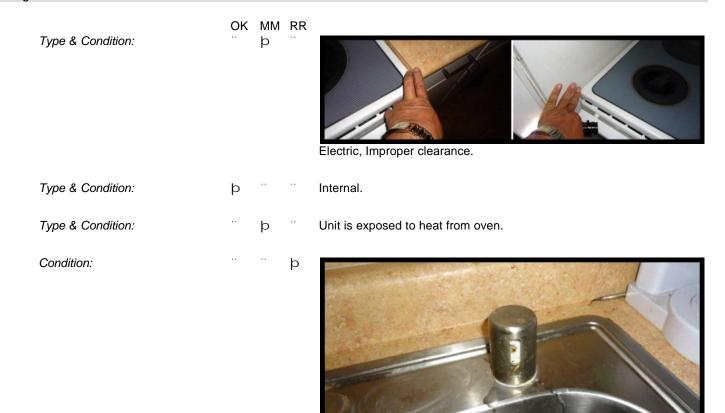
Backing up though air gap.

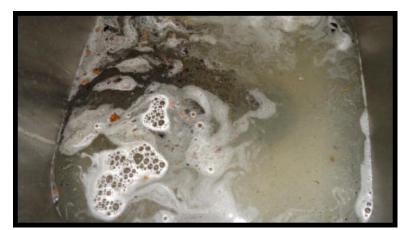
Jammed at time of the inspection.
