Report: 620 Sacramento Ave, Spring Valley, CA 91977 **Address:**

ACE HOME INSPECTION

May 16, 2013

Inspected By: Donald L. Walker

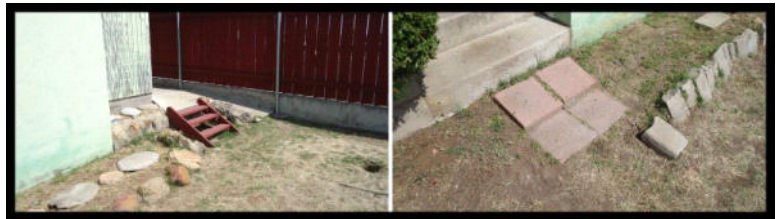
Handrails needed, Improper rise/run on steps.

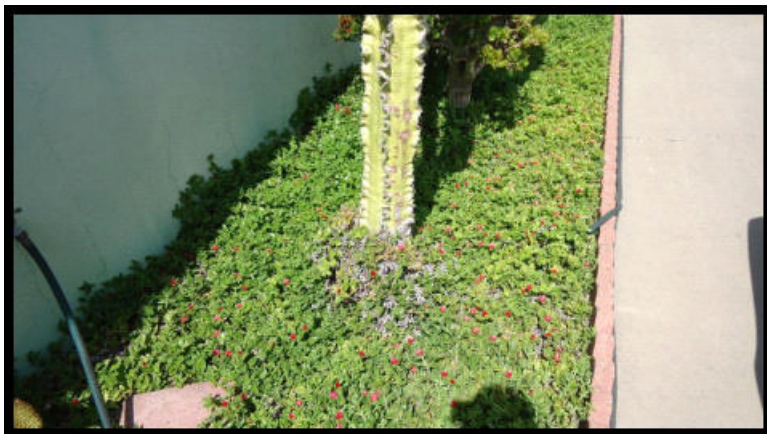
Bed are retaining water.

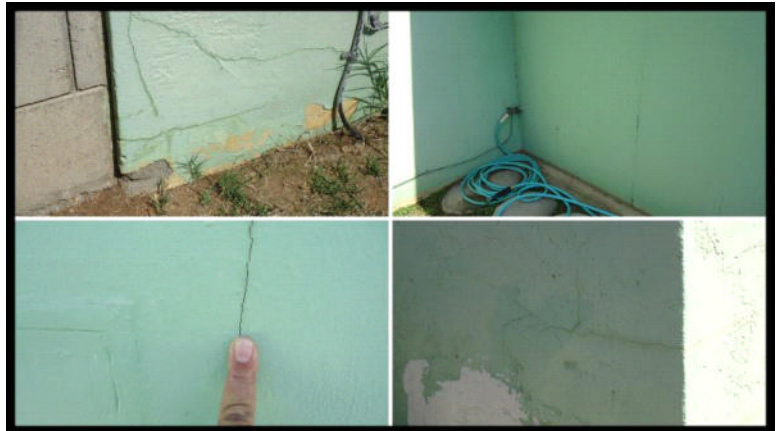
Cracks noted are major, Damaged siding.

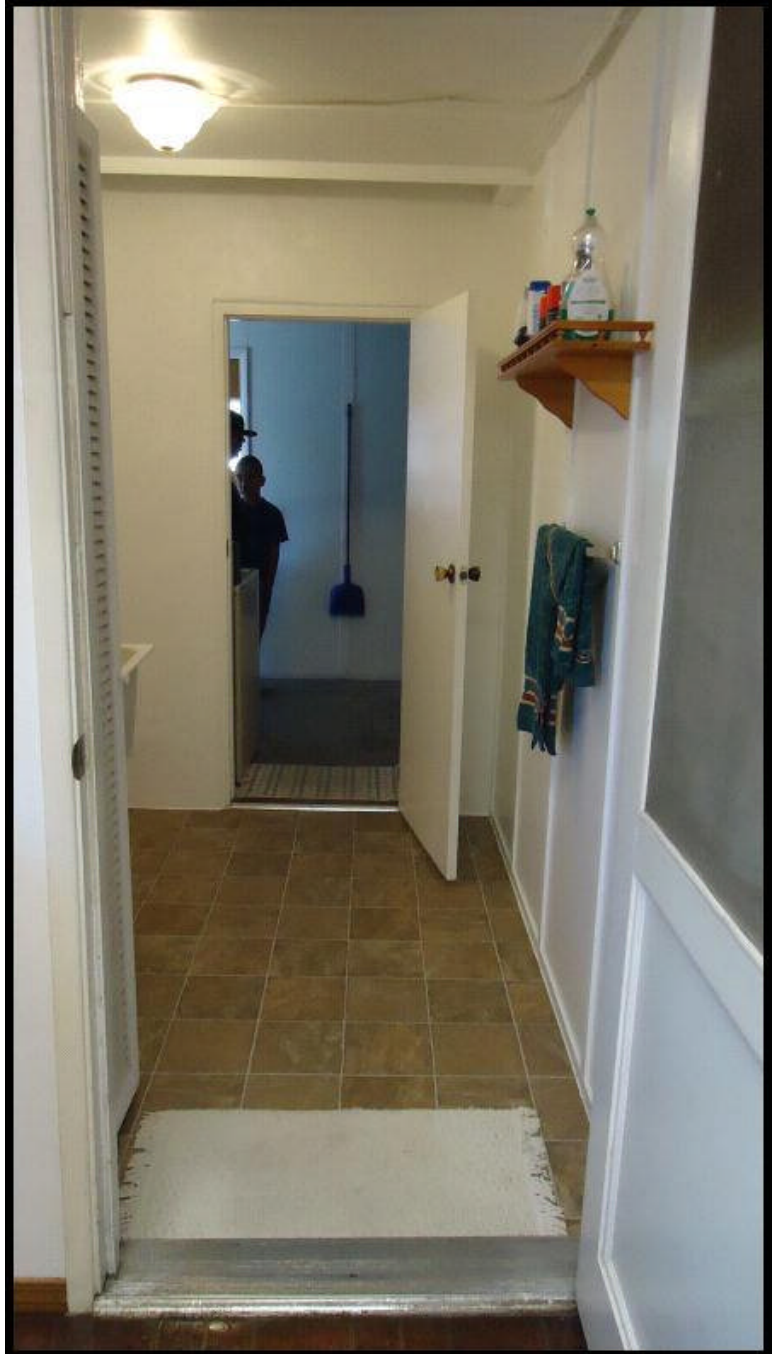
There is no self closing fire rated door separating the garage from the living areas of the house.

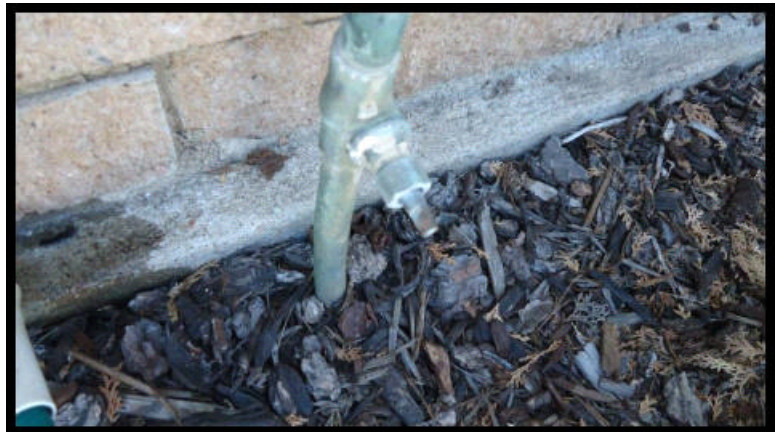
Missing handle.

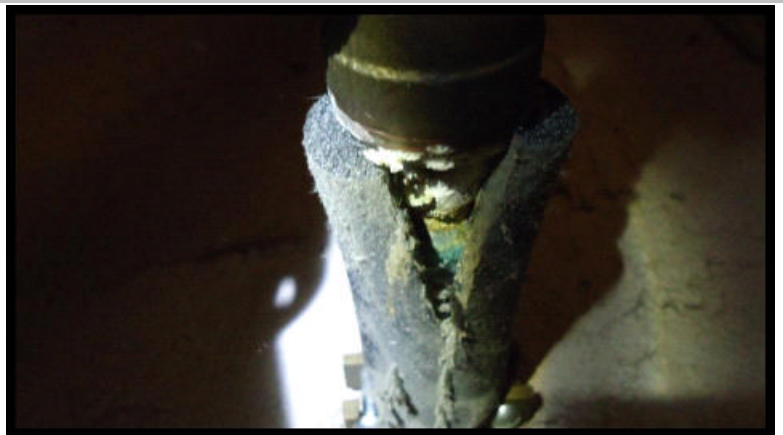
Corrosion is noted, There is evidence of encrustation and/or mineral deposits that may be signs of deterioration. However, no leaks are visible.

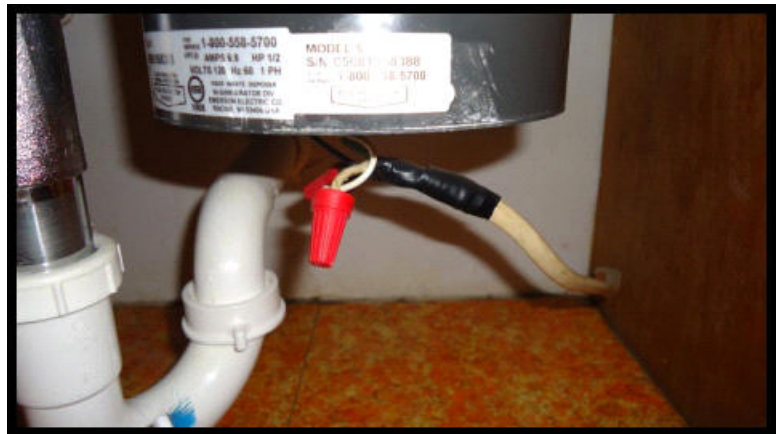
Improper wiring.

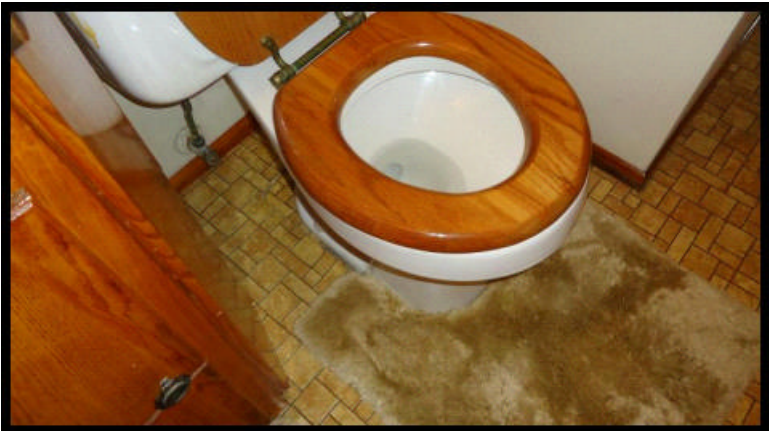
The following problems were noted at the toilet: Toilet is loose at floor.

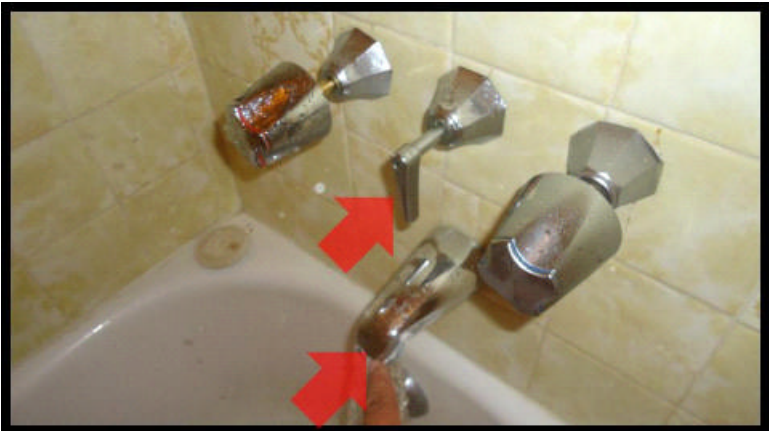
Diverter is weak or not operable Corrosion/Damage noted. When using the diverter pieces fell out.

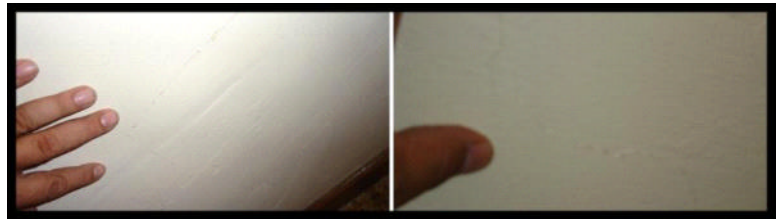
Typical cracks noted.

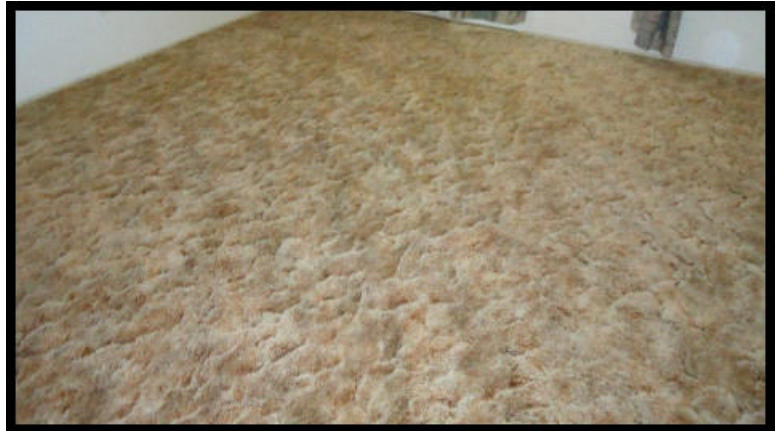
Uneven areas noted.

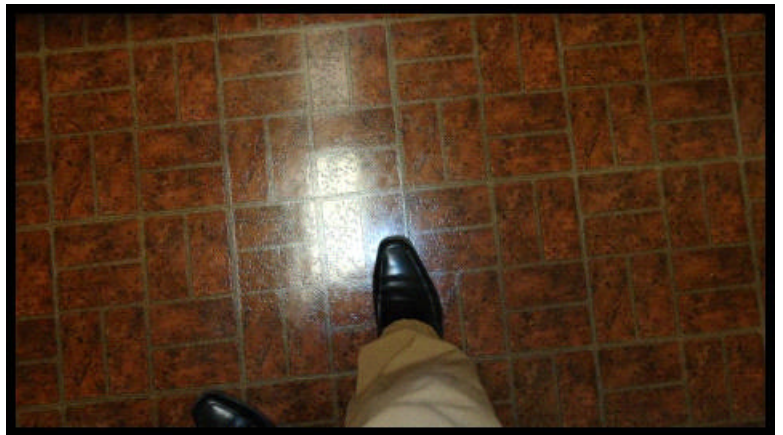
The floor covering material is not proper.

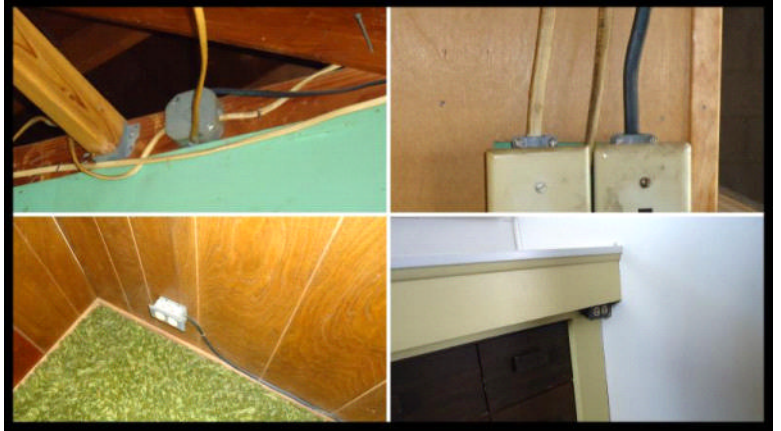
Garage Walls:

Over extended with different wires tied together.

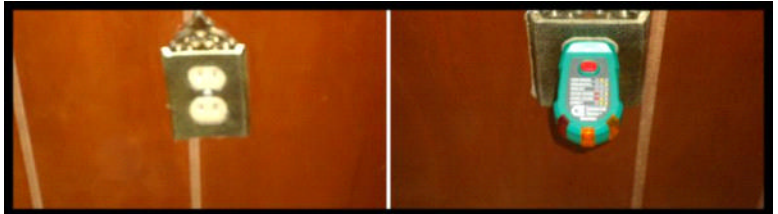
Some grounded type outlets did not appear to be properly grounded. two prong noted.

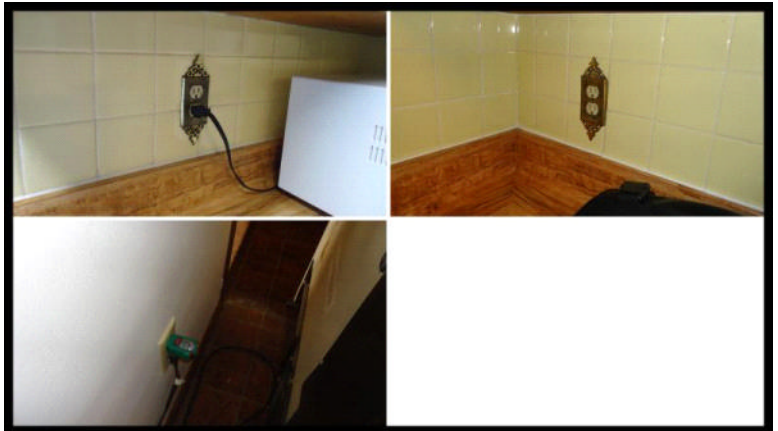
Kitchen Interior:

Some grounded type outlets did not appear to be properly grounded. Ground Fault Circuit Interrupter (GFCI) outlets are recommended for installation at exterior, garage, bath rooms & kitchen outlets. Refrigerator is plugged into a two prong receptacle. We suggest upgrading to a grounded type receptacle.

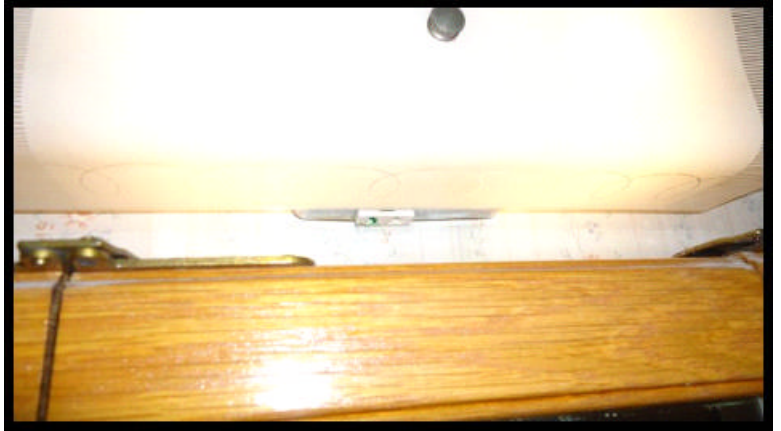
Master Bath:

Ground Fault Circuit Interrupter (GFCI) outlets are needed for exterior, garage, bath rooms & kitchen outlets.

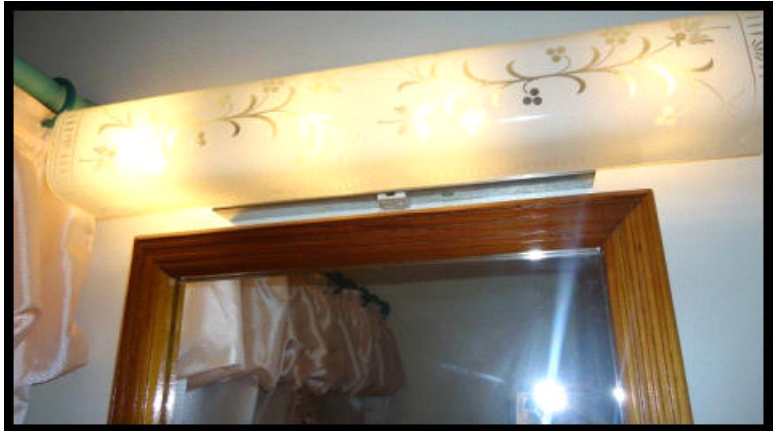
Bath Between Bedrooms:

Ground Fault Circuit Interrupter (GFCI) outlets are needed for exterior, garage, bath rooms & kitchen outlets.

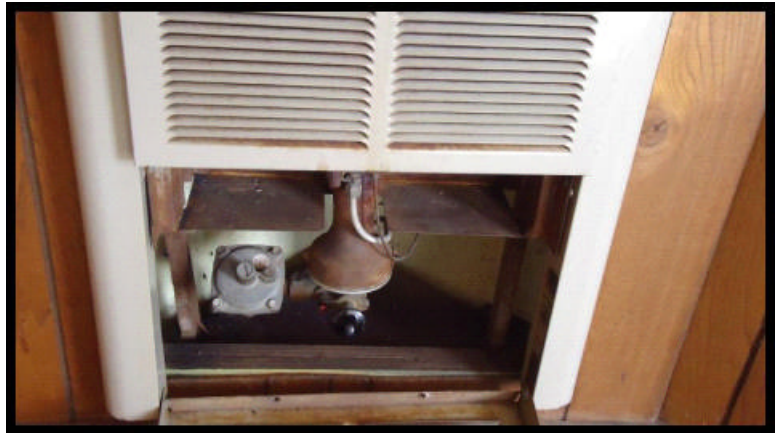
Rust noted.

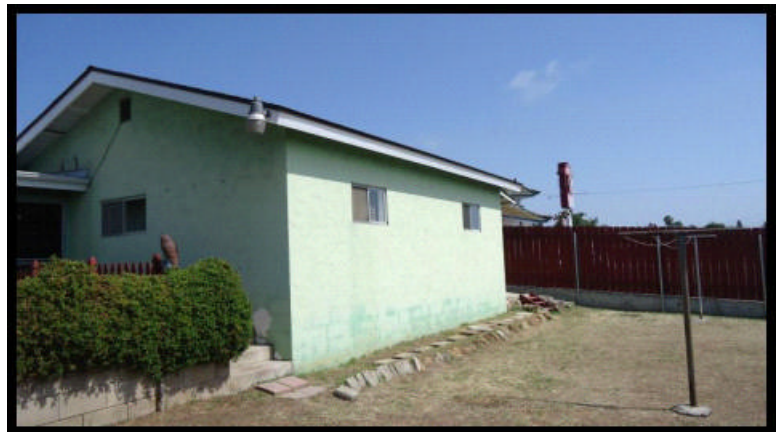
Consider installing gutters and downspouts to help with site drainage, Missing downspouts.

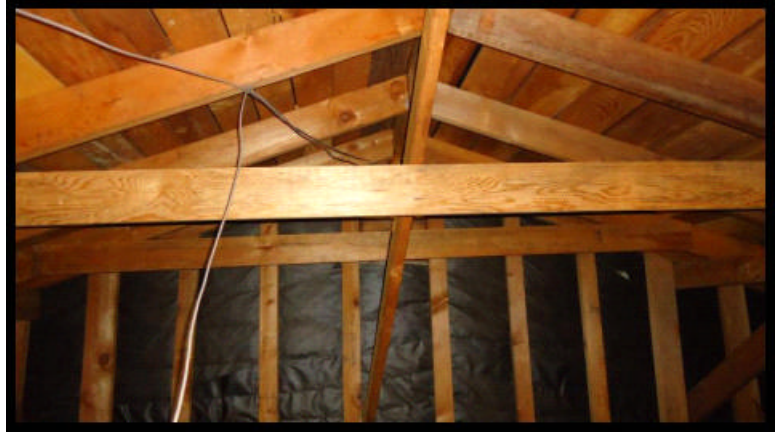
There is some ventilation installed; however, the existing venting does not allow adequate ventilation for the attic cavity. Action is necessary to correct this shortage of ventilation.
