# ACE HOME INSPECTION

**4034 Mark Terrace, San Diego, CA 92117**

**Dated: 11 May 2014**

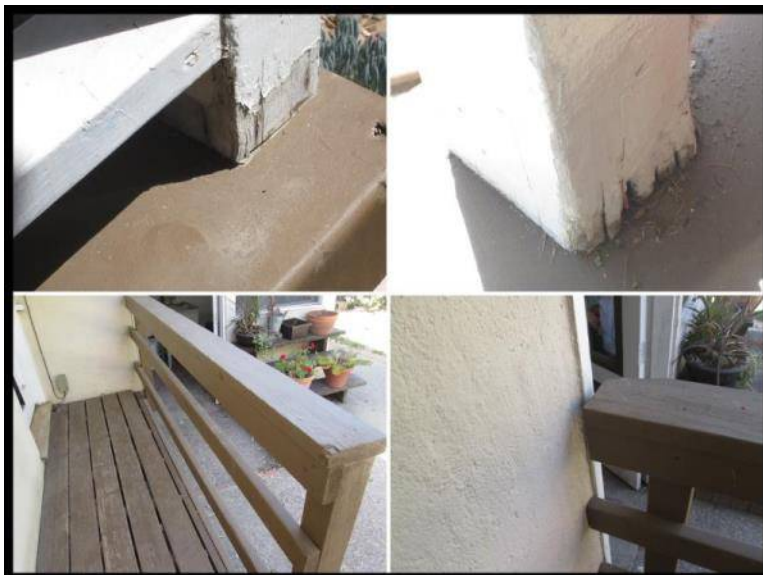
Deterioration noted at base of posts. Improper bracing Needs repair or securing.

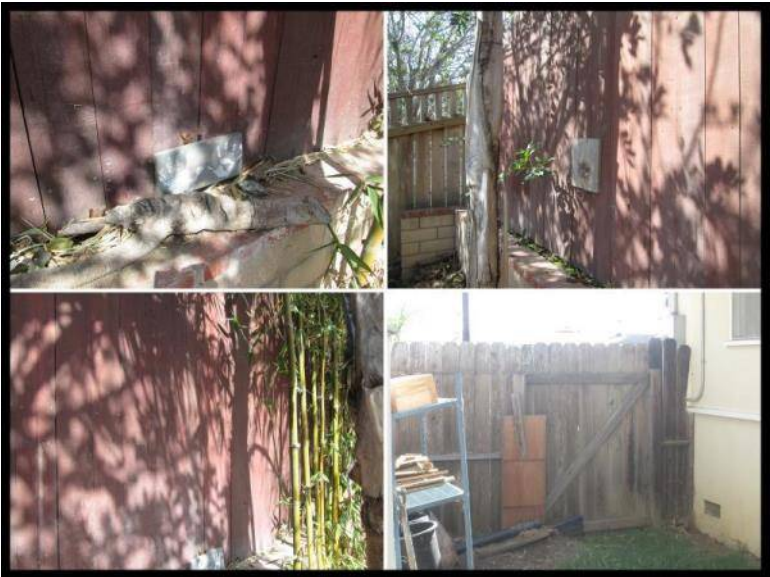
Damaged Gate needs repair or adjustment, Loose/rotted posts.

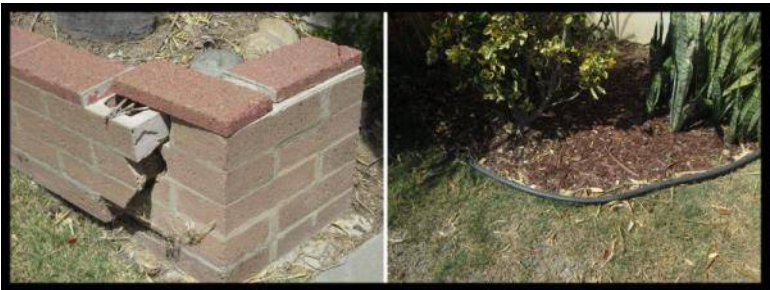
Displacement/Cracks major. Barrier holding moisture next to walls.

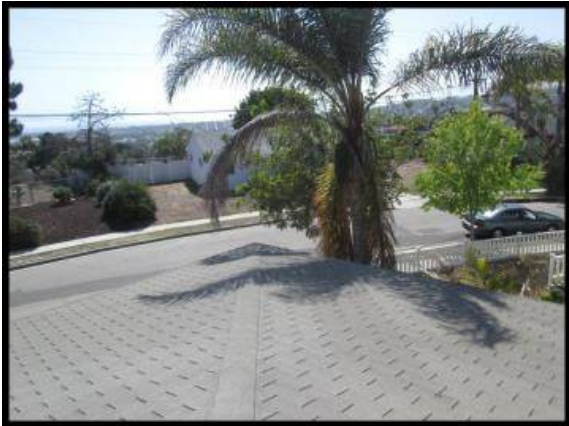
Trees are touching or overhanging the roof. Damage is possible.

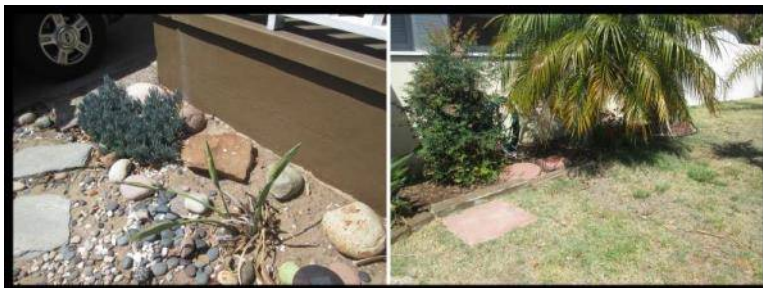
Poor with wells noted.

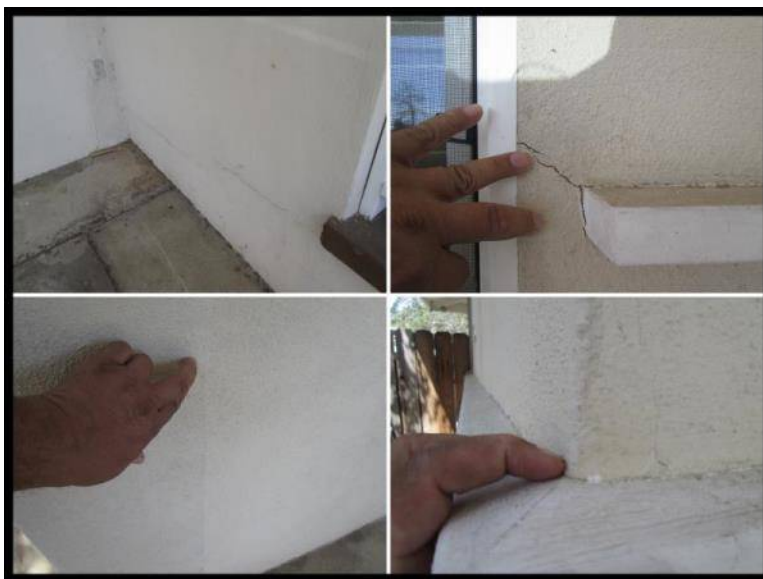
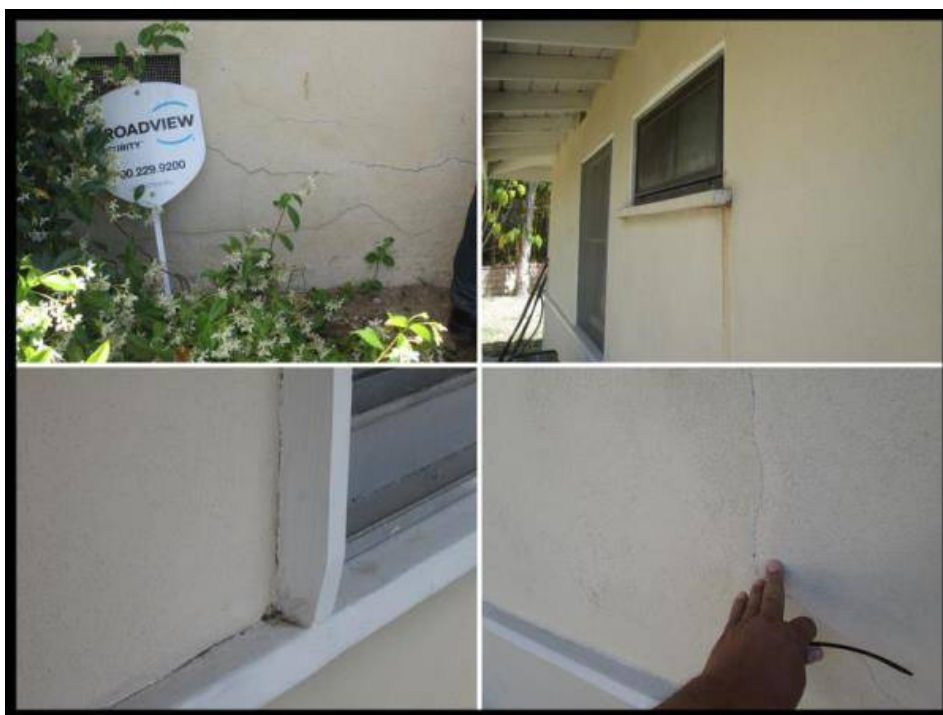
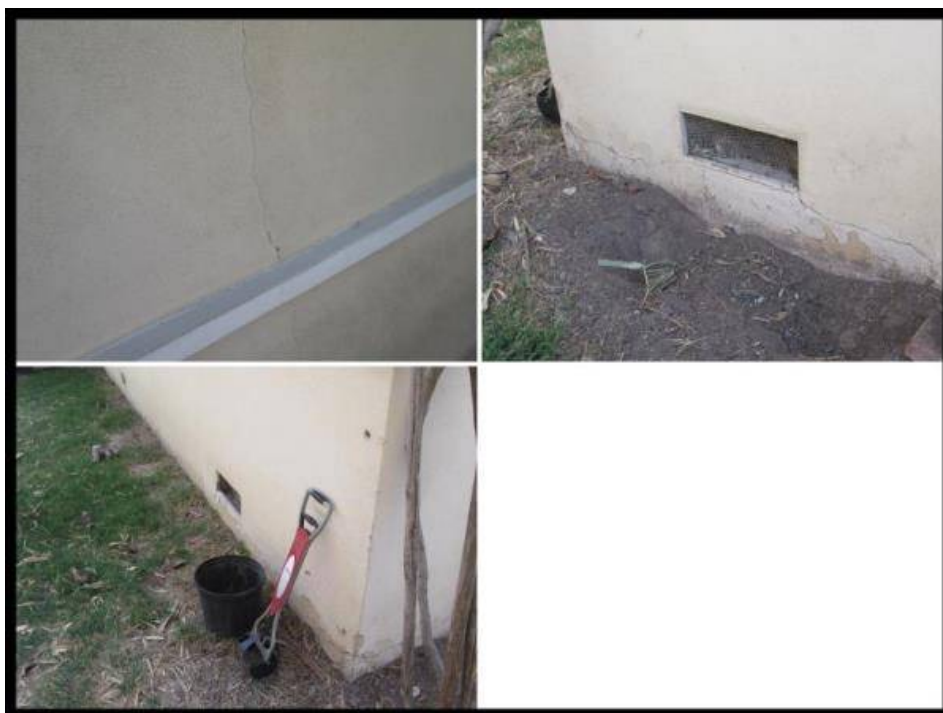
Cracks noted are major, Damaged/rotted from moisture.

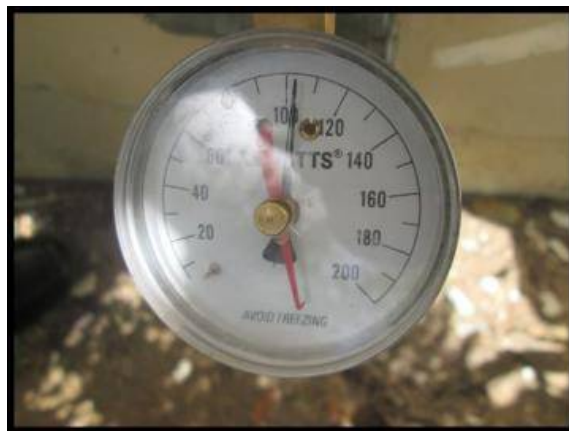
Water pressure from 40 to 80 pounds per square inch is considered within normal/acceptable range. Water pressure was over 80 pounds per square inch and is considered excessive. Suggest the supply should be adjusted to below the 80 pound maximum. If the supplying utility company cannot adjust the pressure for you, then a water pressure regulator valve is recommended.

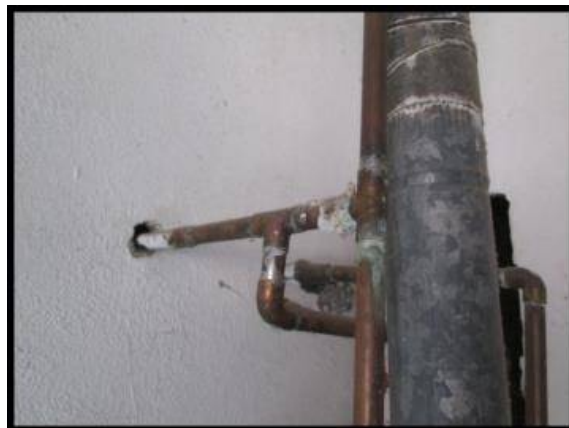
☐ ☒ ☐ Drop down lines  
in use Minor  
corrosion is  
noted.

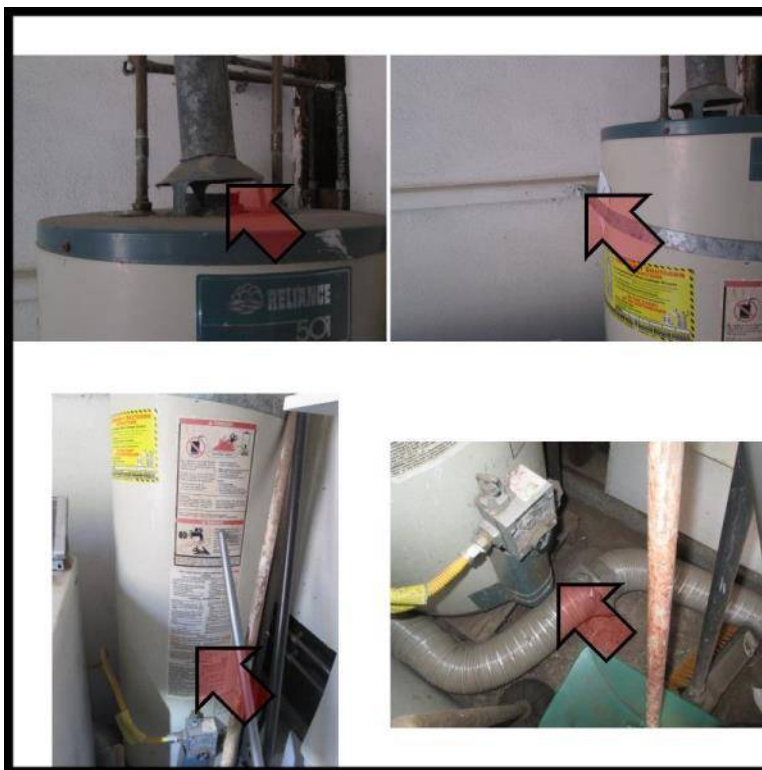
Improper venting noted, Pressure relief valve drain line is missing or ends prematurely. This is a SAFETY HAZARD. We recommend this drain line be extended to a safe location, Corrosion is noted, Water heater is not correctly or inadequately secured and needs to be strapped in accordance with local standards., improper base noted.

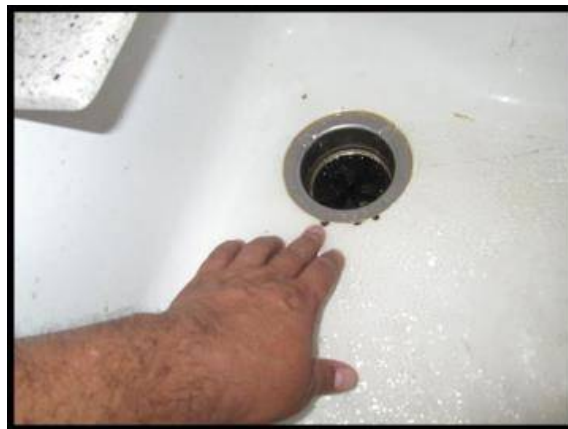
☐ ☒ ☐ Minor wear noted.

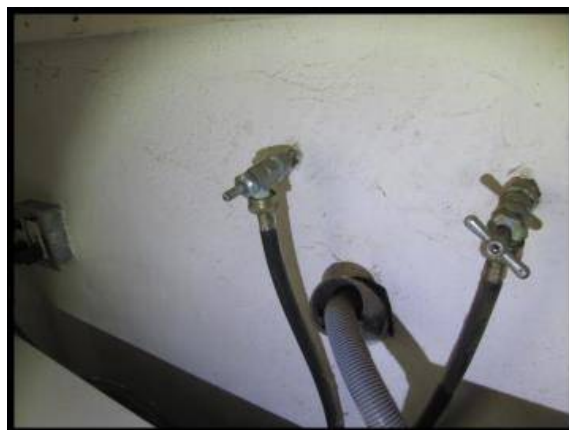
- ☐ ☐ ☒ Damaged handle  
Corrosion noted.

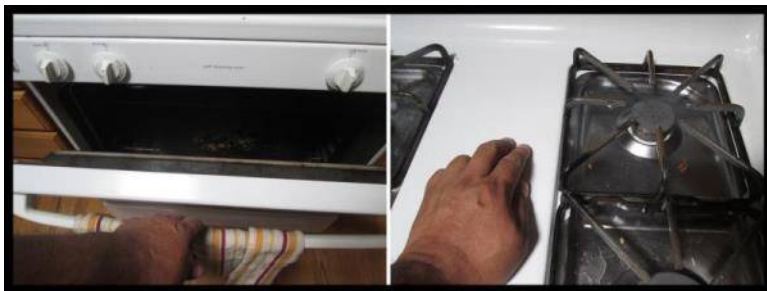
When set to low, burners can go out when opening door, one burner went out when set to low.

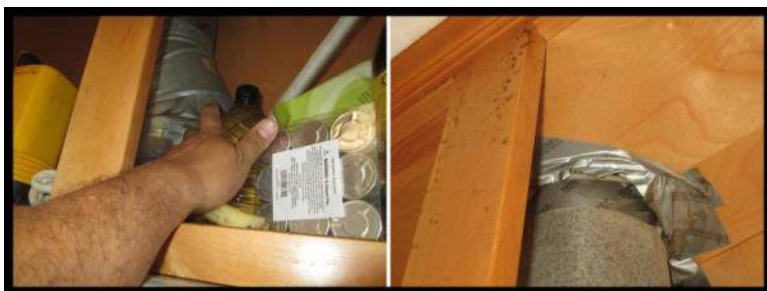
Air leak noted Improperly taped.

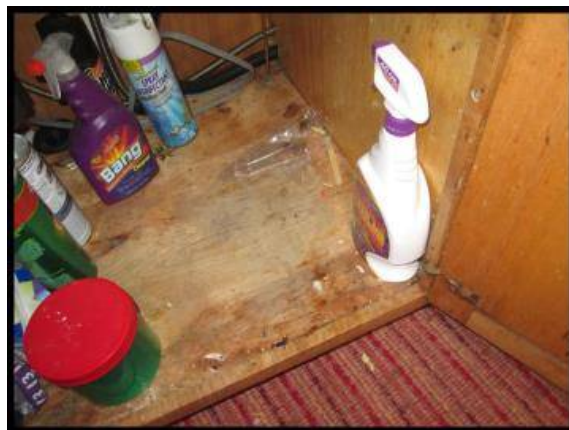
OK MM RR  
☐ ☐ ☒ Cabinets are  
damaged.

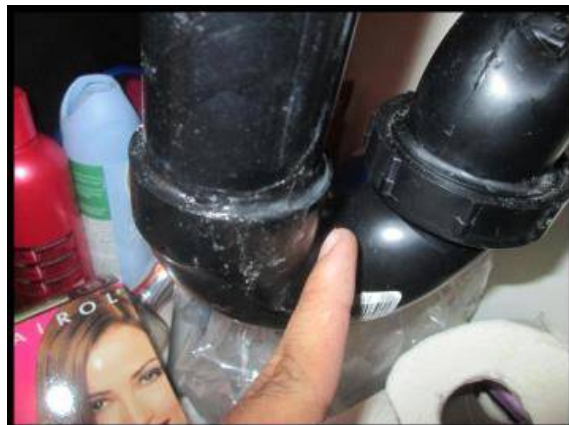
The following problems were noted at the sink:  
 Minor Leak noted.

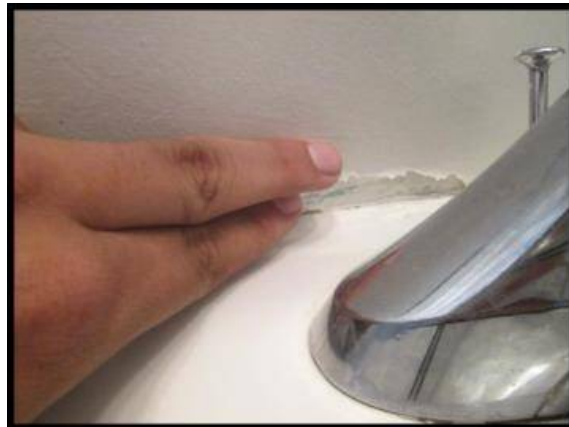
Caulk and seal, Sink fetter line has corrosion and rust on it.

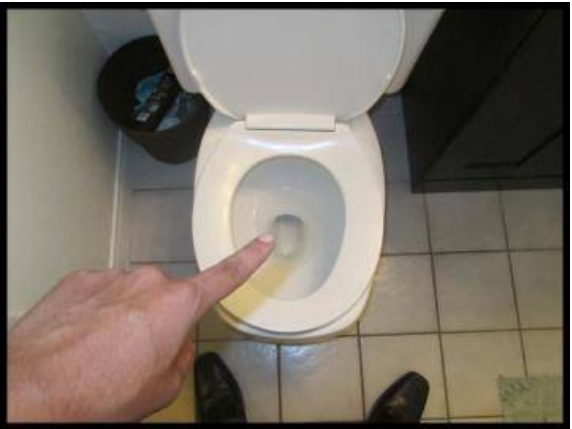
- ☐
- ☐
- ☒
- The following problems were noted at the toilet: Toilet is loose at floor.

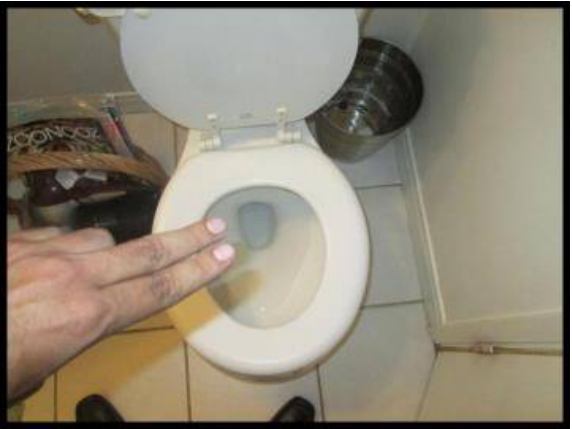
- ☐ OK
- ☐ MM
- ☒ RR
- The following problems were noted at the toilet: Toilet is loose at floor.

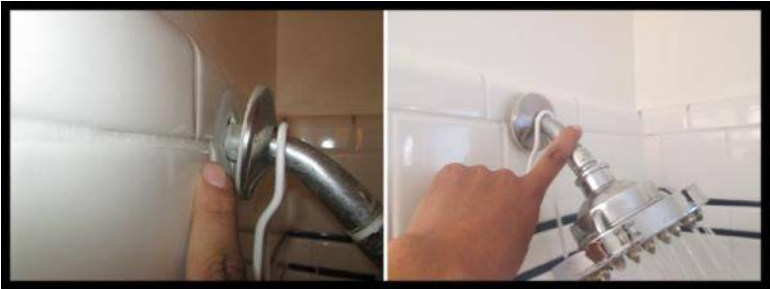
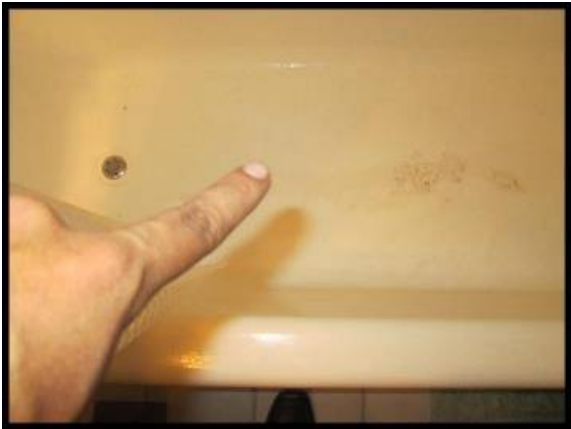
Loose back plate to shower head Loose plumbing. Tub has been resurfaced.

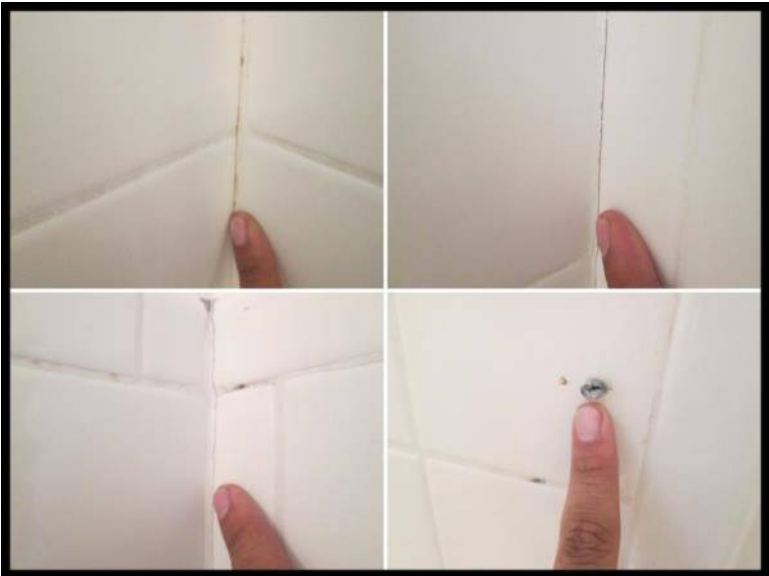
Nails noted in the wall Caulk and seal all tub and shower areas as a precaution.

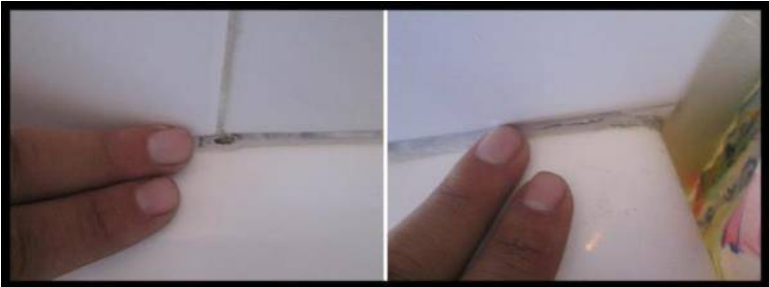
Caulk and seal all tub and shower areas as a precaution.

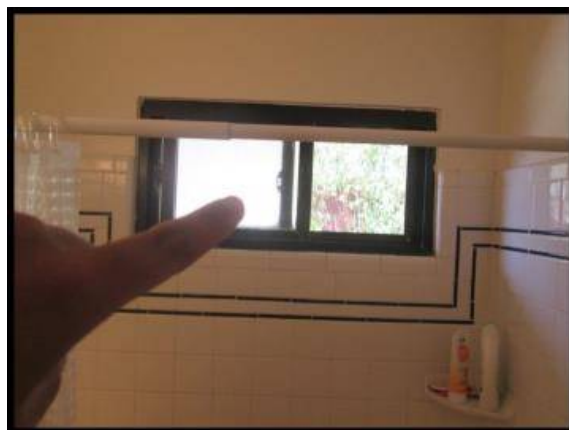
- ☐ ☒ ☐ None or inadequate ventilation noted. Only a window is provided for ventilation.

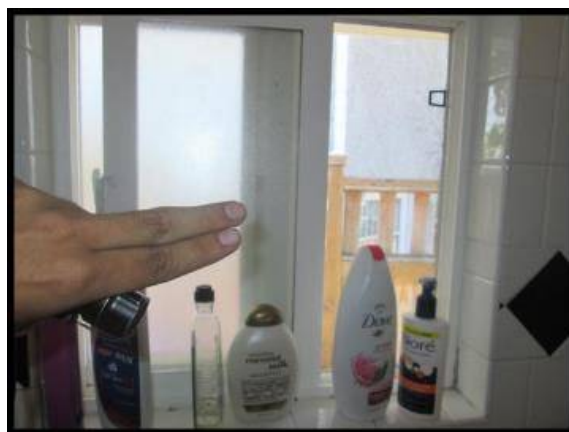
- OK MM RR  
☐ ☒ ☐ None or inadequate ventilation noted. Only a window is provided for ventilation.

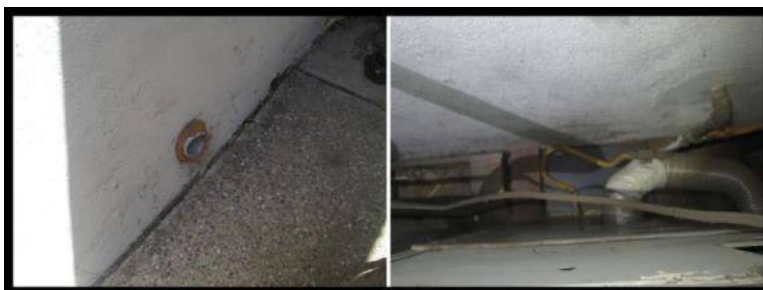
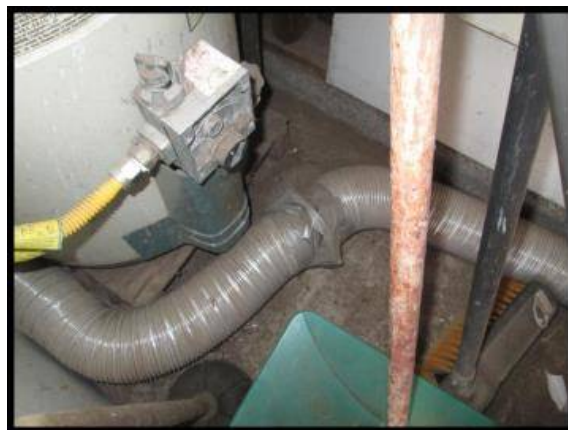
Improper seal, trimmed.

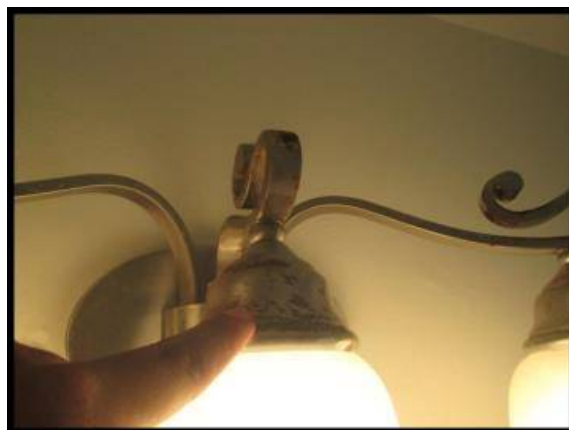
☐ ☐ ☒ Rust noted on  
fixture.

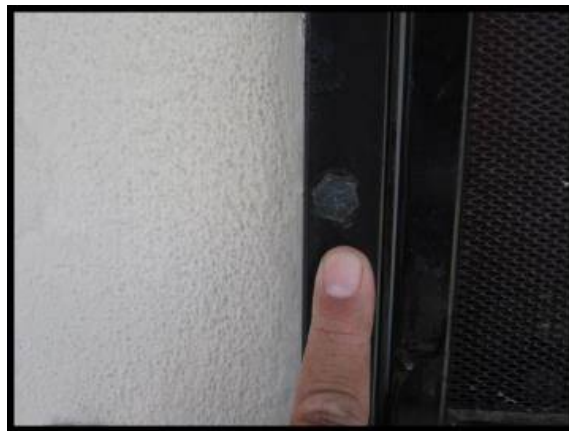
Improper bolts for  
the security door.

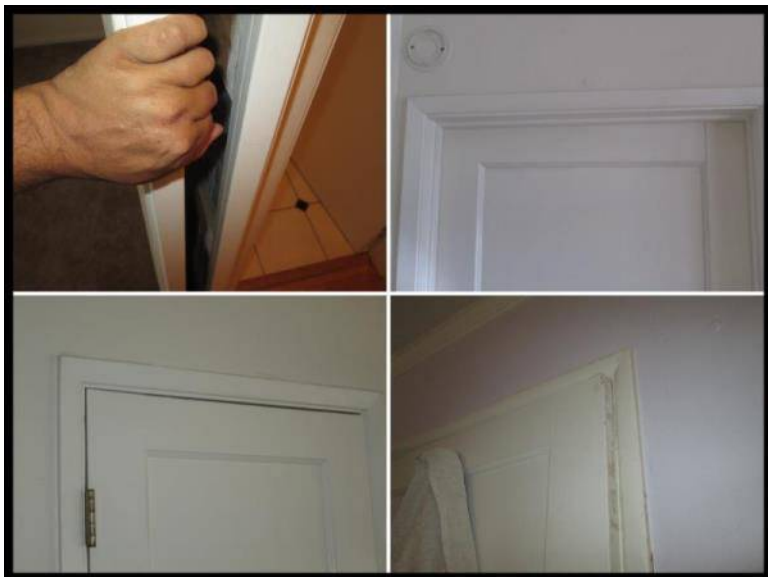
Missing pocket door, rubs sticks, doors have been adjusted and shaved.

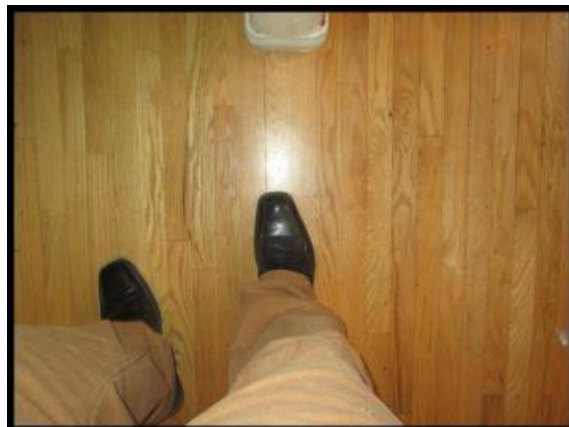
*General:*                    ☐   ☒   ☐   Uneven areas noted.

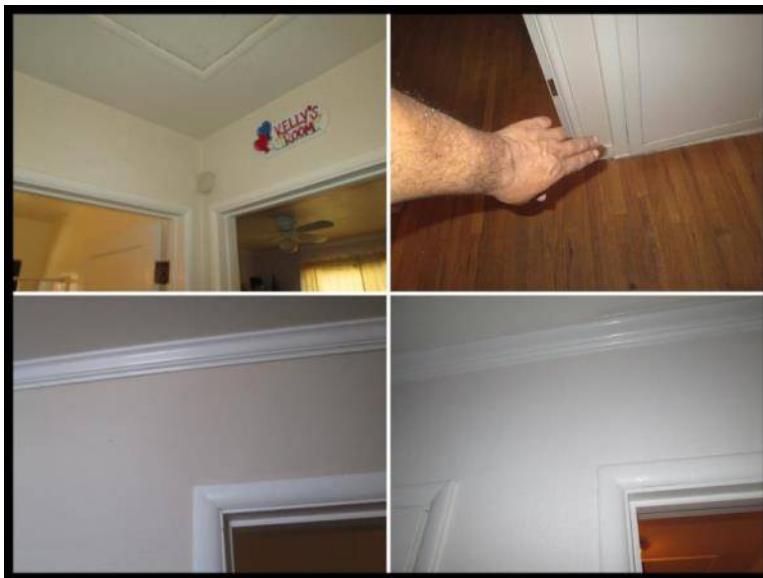
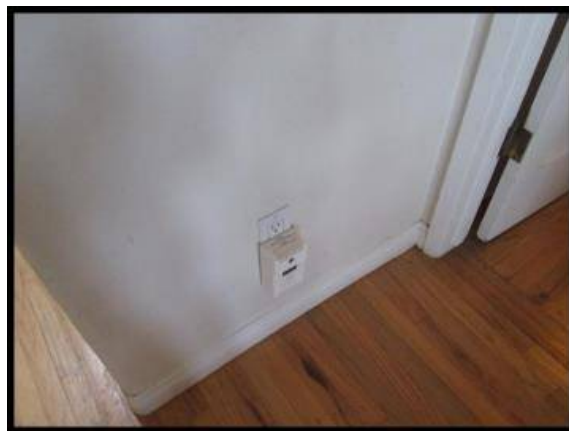
We suggest additional smoke detectors be installed in appropriate locations, Move Co detector Replace missing and or damaged detectors.

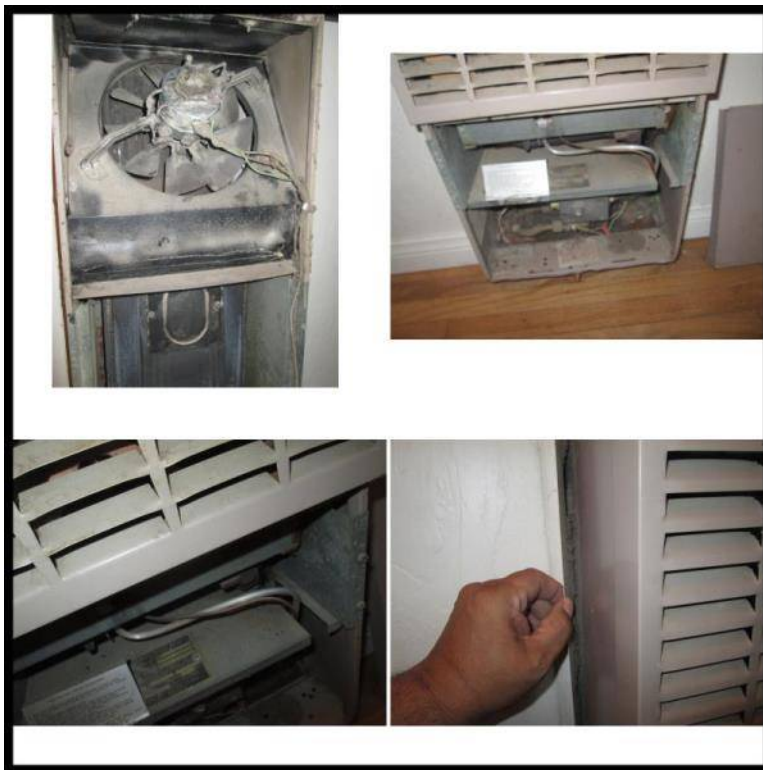
Suggest cleaning/servicing blower motor, pilot light, vent system and burners. Improper feeder line, improperly trimmed.

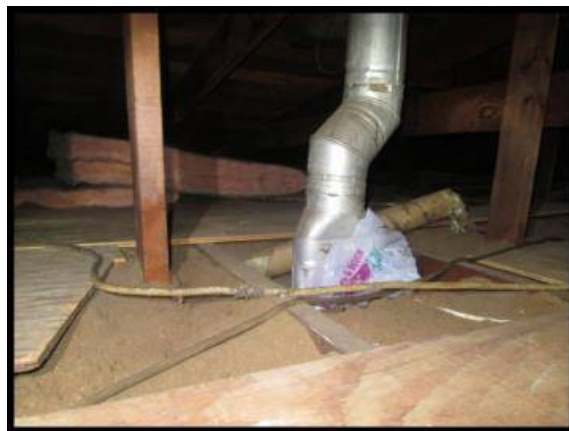
Remover plastic  
from around vent.

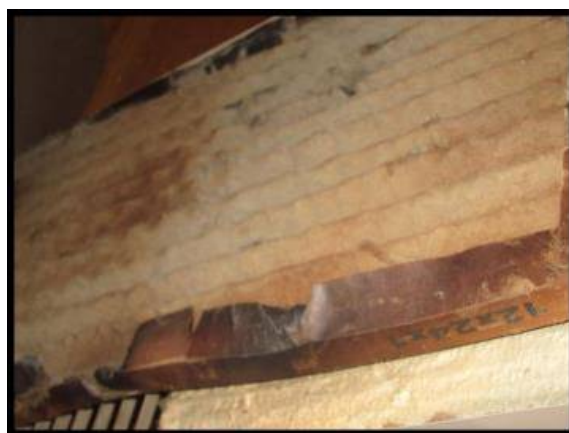
Remove it.

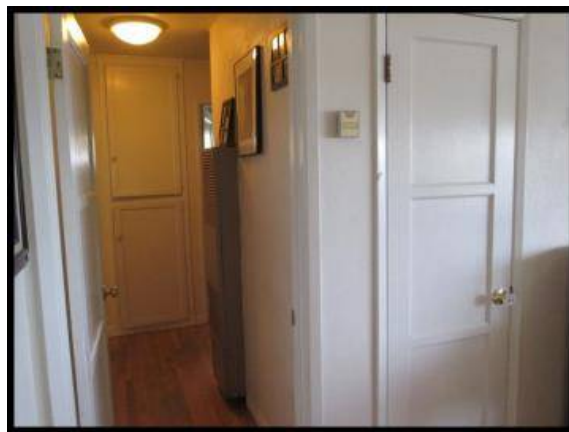
The location of  
the thermostat is  
not efficient. The  
thermostat  
should not be  
installed in a  
draft area where  
the exterior cold  
or hot air hits the  
thermostat when  
the exterior doors  
are opened.

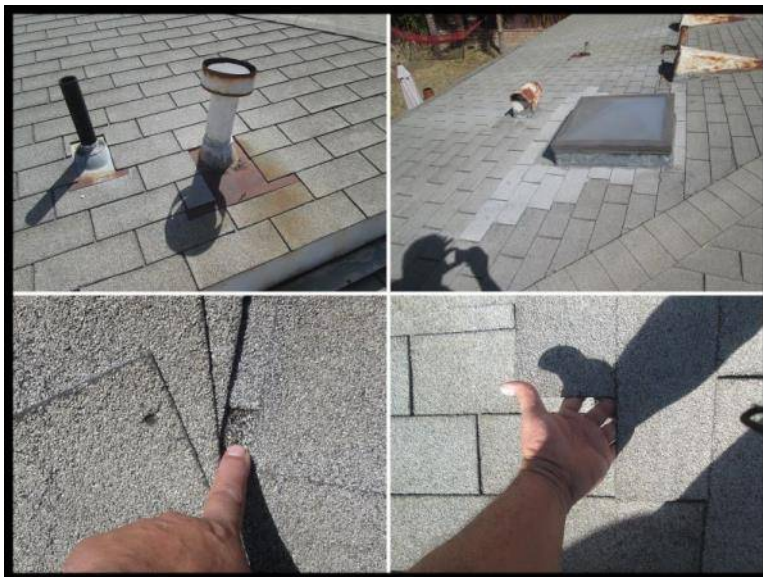
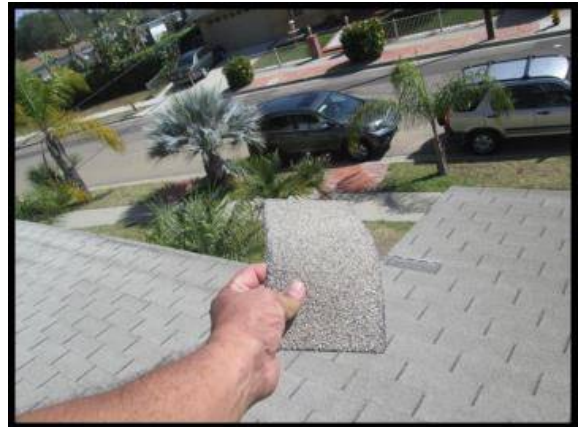
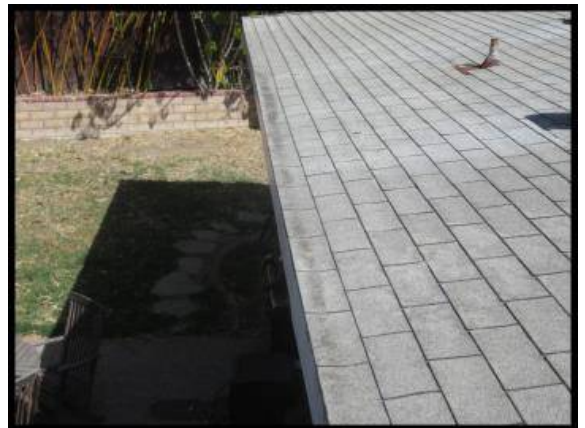
Cracking and clawing of shingles are the result of long term weathering and an advanced shingle age. Felts are showing through, TYPICAL MAINTENANCE RECOMMENDED. This usually consists of repair/replacement of damaged/missing shingles. This maintenance should help insure the weather tightness of the building and should be performed on a regular basis. Damage/Deterioration/Defects noted.

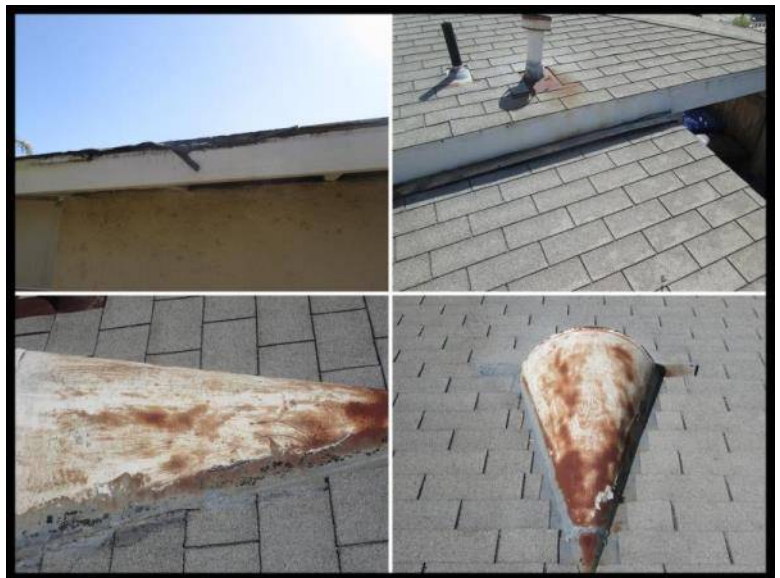
Rusty flashing is noted, Flashing is cracked, Damage is noted.

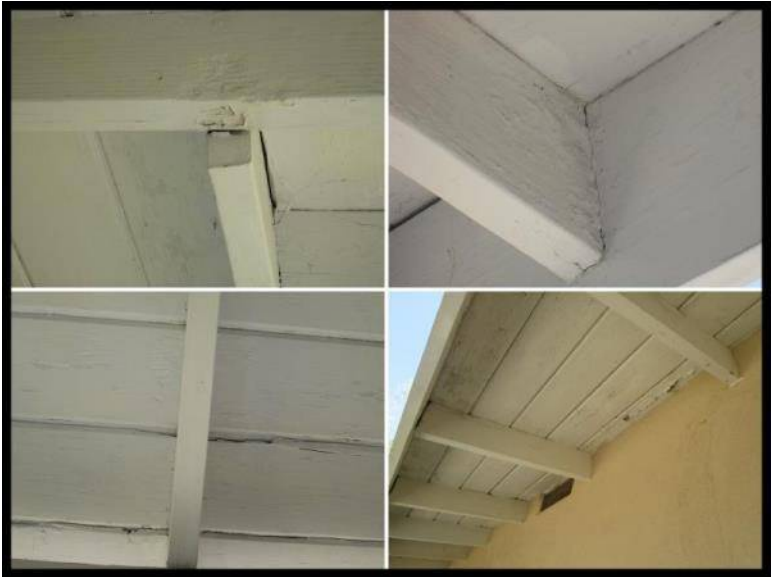
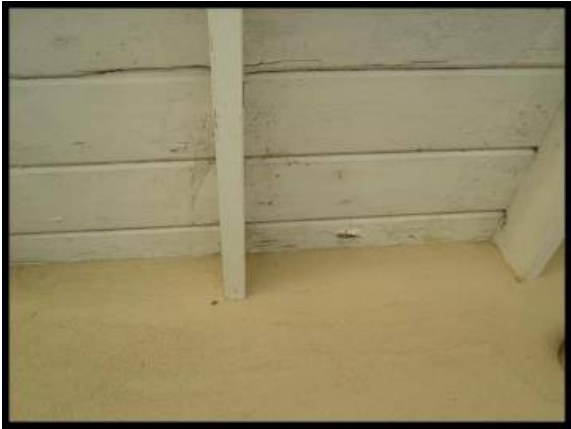
Deterioration at overhangs noted. Repairs or painting needed to

prevent ongoing deterioration.

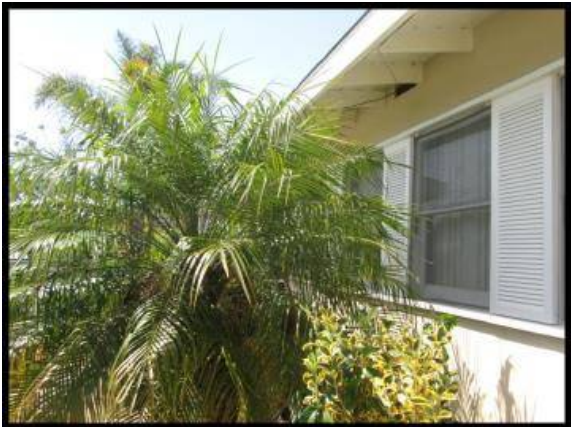
OK	MM	RR	Consider installing gutters and downspouts to help with site drainage.
<input type="checkbox"/>	<input type="checkbox"/>	<input checked="" type="checkbox"/>

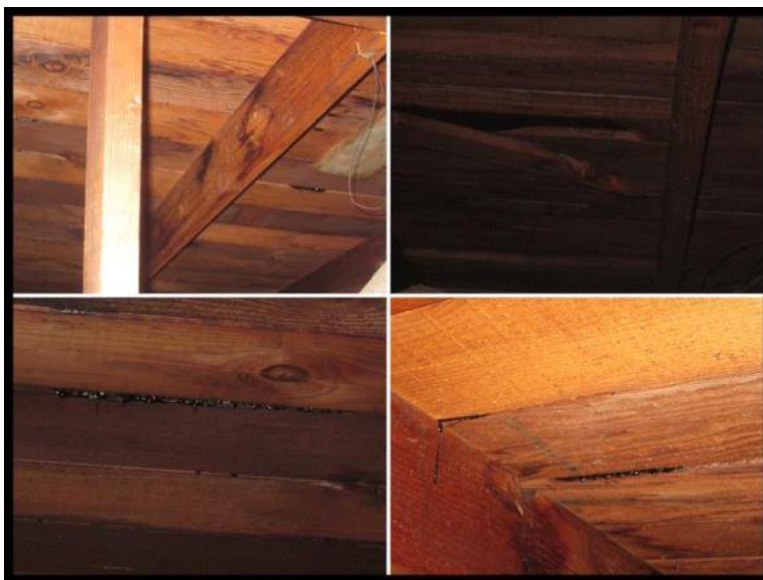
Stains noted, repairs noted, damaged.
